Manhole Inspection Summary

Manhole # S21GG2005MH

Insp Date: **11/9/06 2:59 PM**

Location Address: **1115 BRYN MAWR RD**

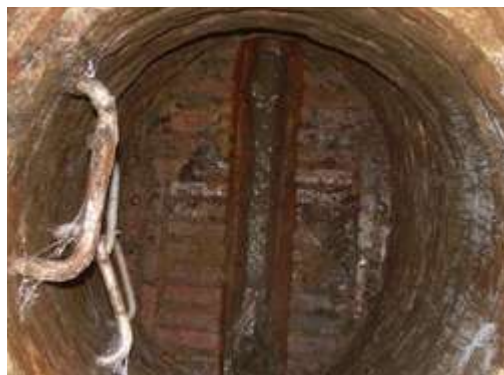
Top View

Corroded steps. Evidence of surcharge - Bench debris.

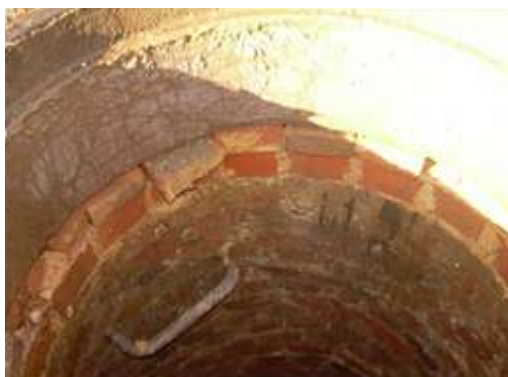
Defect

Frame offset. Adjustment deterioration, loose brick and infiltration. Corbel infiltration.

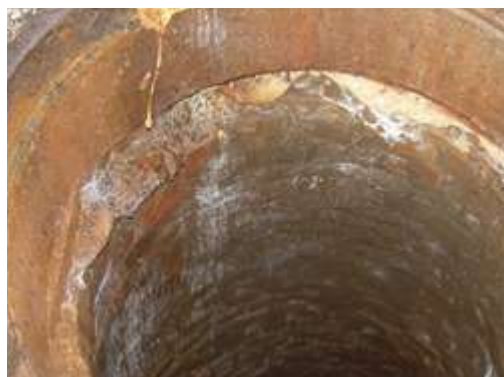
Defect

Frame leaks. Frame offset. Adjustment deterioration, loose brick and infiltration. Corbel infiltration. - other side.

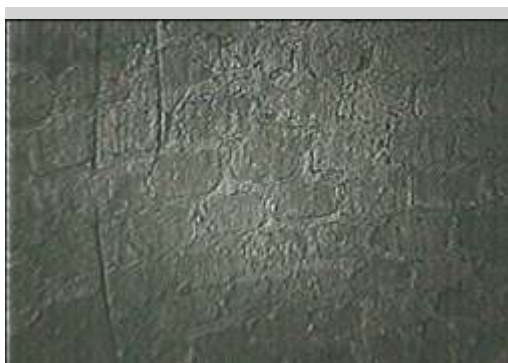
Defect

Barrel deterioration and infiltration.

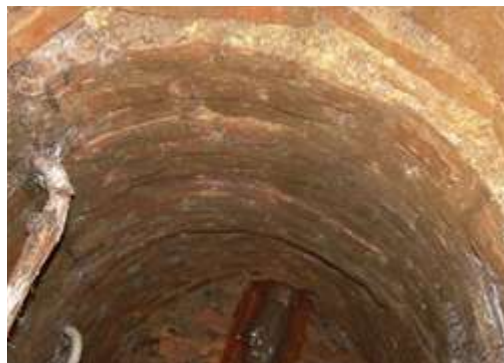
Defect

Frame leaks. Adjustment, Corbel and Barrel infiltration.

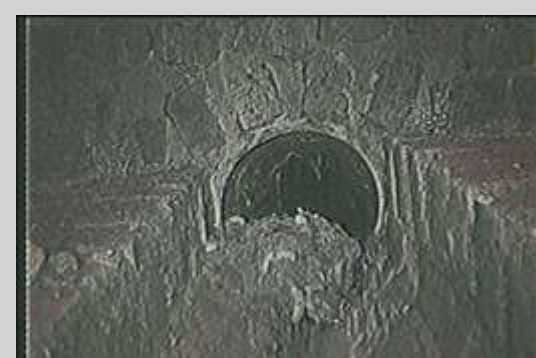
8 in. Circular Gravity Sewer Pipe In @ 6 O'Clock

Deposits: ☐ None ☐ Mud ☐ Sludge ☒ Debris ☒ Grease

Silt Depth: **0** (in.) Deposits Extent: **Medium**

Infiltration: **Evidence** Pipe Seal Cond: **Cracked**
